11-
12) 10
**RESPONSE OF BURIED VERTICALLY ORIENTED CYLINDERS
TO DYNAMIC LOADING**

GAYLE E. ALBRITTON, * AND JIMMY P. BALSARA
U. S. Army Engineer Waterways Experiment Station
Vicksburg, Mississippi 39180

JUN 1980

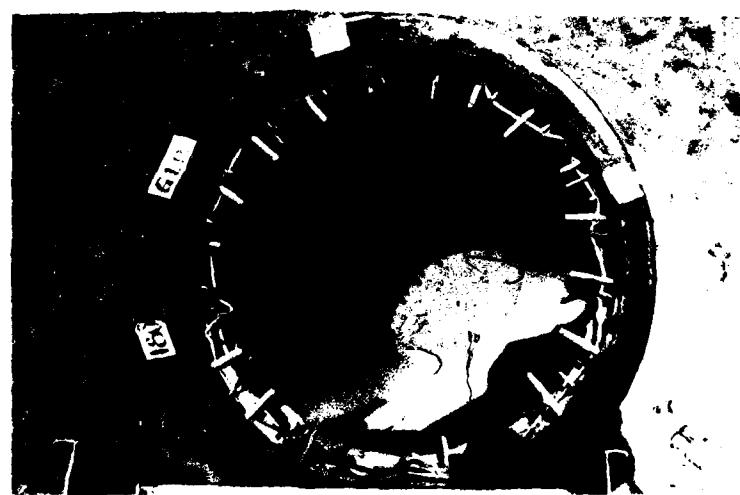
Posttest check of the DEOT 3 cylinders indicated a length change of 9.53, 2.54, and 0.64 cm (3-3/4, 1, and 1/4 inch), respectively, for the thinnest, middle, and thickest cylinder. The thinnest cylinder, G.1.D, had a vertical crack on the exterior which was wide and open completely through the cylinder. The middle cylinder, F.2.D, showed some exterior crushing below the top and some circumferential spalling at approximately midheight. There was also some cracking below the top exterior for the thickest cylinder, F.3.D. Posttest views of damage to the interior of each cylinder are shown in Figures 8 through 10. Damage to these cylinders was more drastic on the inside with considerable crushing and spalling at the cylinder top portion. The overall damage to the DEOT 3 reinforced concrete cylinders was much greater than that observed for the DEOT 1 and 2 cylinders with inner liners.

Figure 8. Damage to interior of cylinder G.I.D ($t = 1.7$ in.) during DEOT 3 test
